ON TRACK!

CSRМ'S TURNTABLE: A PROJECT IN TWO PARTS

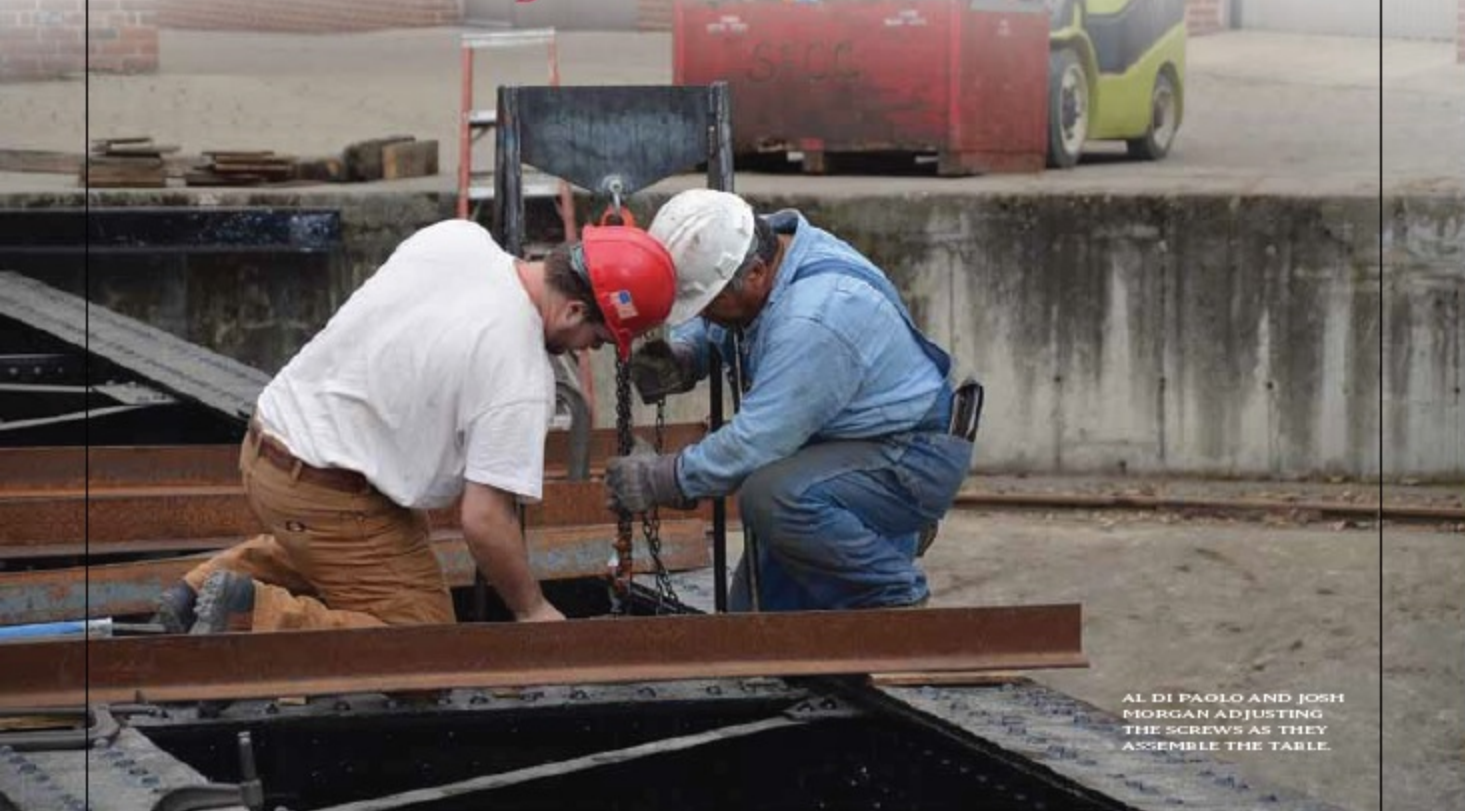
AL DI PAOLO AND JOSH MORGAN ADJUSTING THE SCREWS AS THEY ASSEMBLE THE TABLE.

A considerable amount of time was spent planning and lifting the table; fortunately, many volunteers were on hand to help. With the turntable raised and safely blocked in position, the center bearing was removed along with the adjustment screws. These screws allow the table's height to be adjusted to compensate for deflection.

Prior to the turntable's reassembly, a painting contractor gave it a coat of gloss black paint. Finally, the day came to reassemble the turntable. Things went smoothly as the center bearing was positioned in place. Once that was installed, the new adjusting screws were installed, and, finally, the turntable was lowered to its operating position. Minor adjustments were required to adjust the table to its correct height.

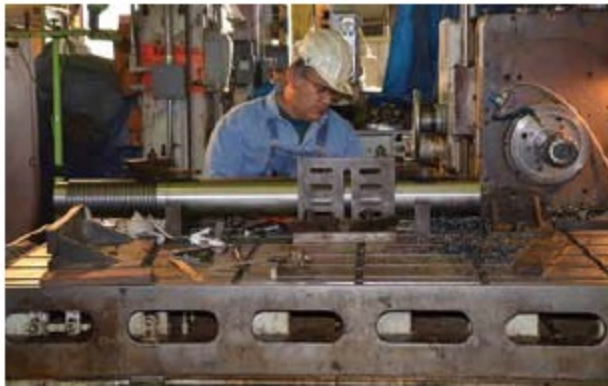
AL DI PAOLO DOING SOME MACHINE WORK ON THE SCREWS.

The bearing's top race and rollers were brought to the Shop, thoroughly cleaned, inspected, and polished to remove rust and pitting. Unfortunately the adjustment screws were frozen on their nuts and could not be salvaged, so the shop made new screws. These have special threads designed to support massive loads and required exacting machine work to complete. Fortunately, the equally massive nuts in which the screws turn were reusable. The adjustment

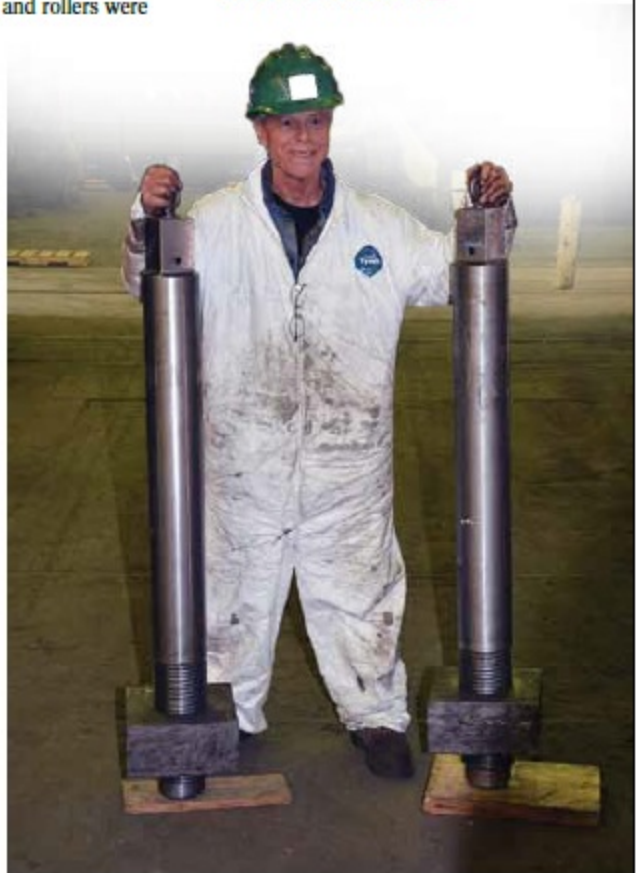
JIM BAYS PROUDLY SHOWING OFF THE NEWLY COMPLETED JACK SCREWS. THE ENTIRE WEIGHT OF THE TABLE SITS ON THESE SCREWS.

screws have special ball shaped heads resting in sockets on top of the center bearing, so the weight on the table, plus any load, bears on about 10 square inches.
